COLONIE DAM

INVENTORY NO. N.Y. 204

PHASE I INSPECTION REPORT NATIONAL DAM SAFETY PROGRAM

AUGUST, 1978

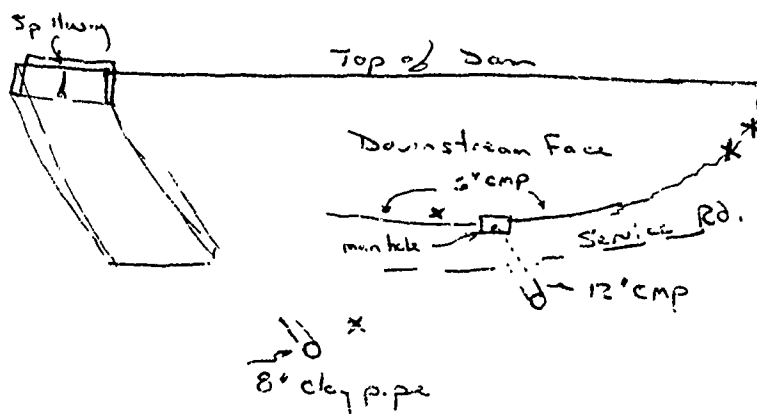
(2) Seepage along Contact of Embankment and Abutment 3 areas of
ponded water with vegetation associated with confined
wet conditions, no flow, 1 area had surface seepage
had a rusty appearance, all near south abutment - none at north abutment

(2) Seepage, unusual growth considerable growth masked the area
however a soft wet area was observed approximately 50
feet west of the south spillway wall near outlet of 8" clay pipe

Note: "X" indicates surface or wet area
